Arlington Street Church

Environmental Stewardship Profile

FACILITY SYSTEMS AND CONDITIONS

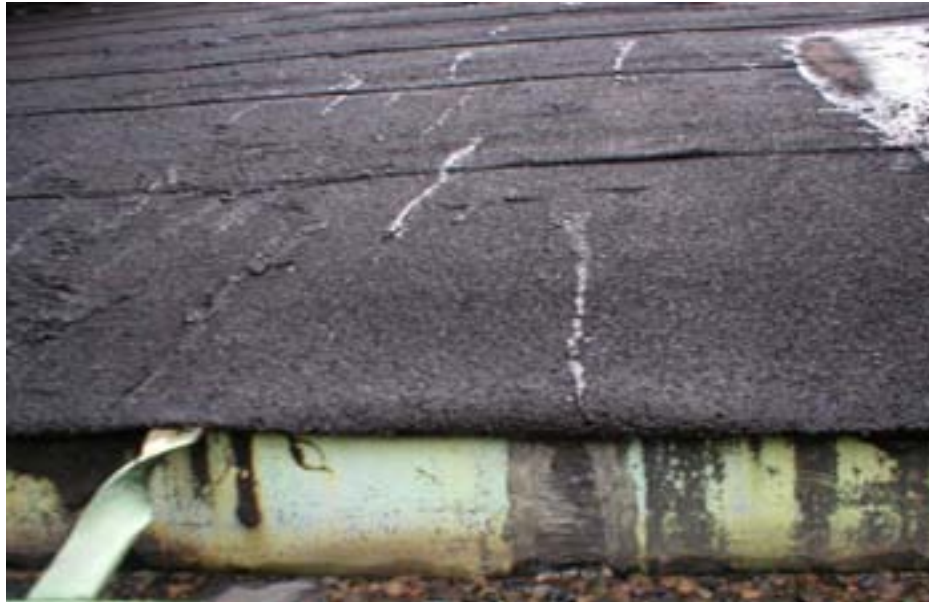
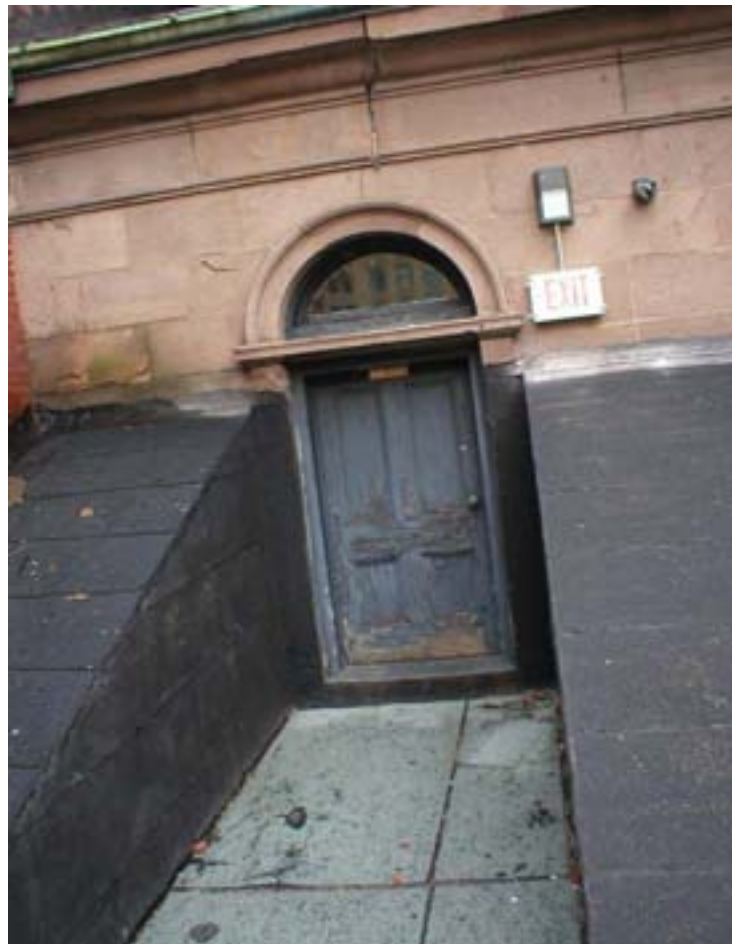
#2 Parish Hall roof areas and door. Both need replacement.

It is recommended that there be an ongoing maintenance schedule to upkeep the exterior masonry work, which is showing deterioration due to age and exposure. The roof areas of the Parish Hall need replacement. Replace damaged door at Parish Hall roof level. Main entry doors to the church are in poor condition allowing for substantial infiltration of cold air in winter months. These doors need general maintenance including full weather-stripping to improve their performance. All of the non stained glass windows should be upgraded to Energy Star windows. The roof cavities above the ceilings in the Parish House and Sanctuary were not accessible during the building audit. All future roofing projects should include evaluation of the structure and potential for installation of thermal insulation to reduce the rate of heat loss.

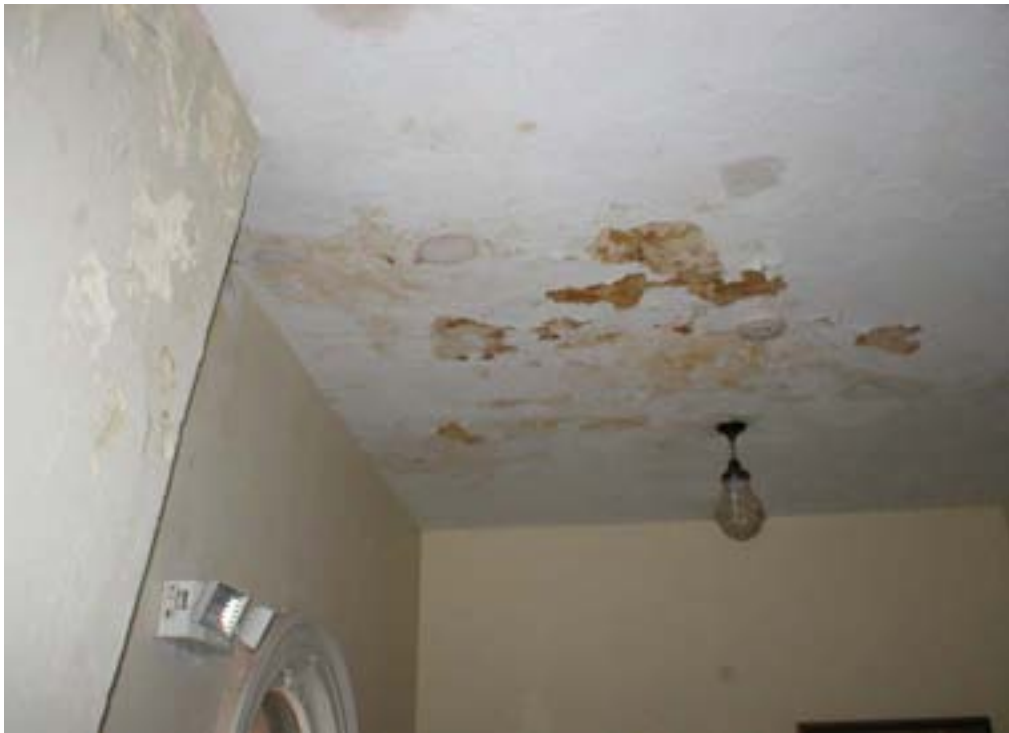
#3 Water damage below these roof areas.

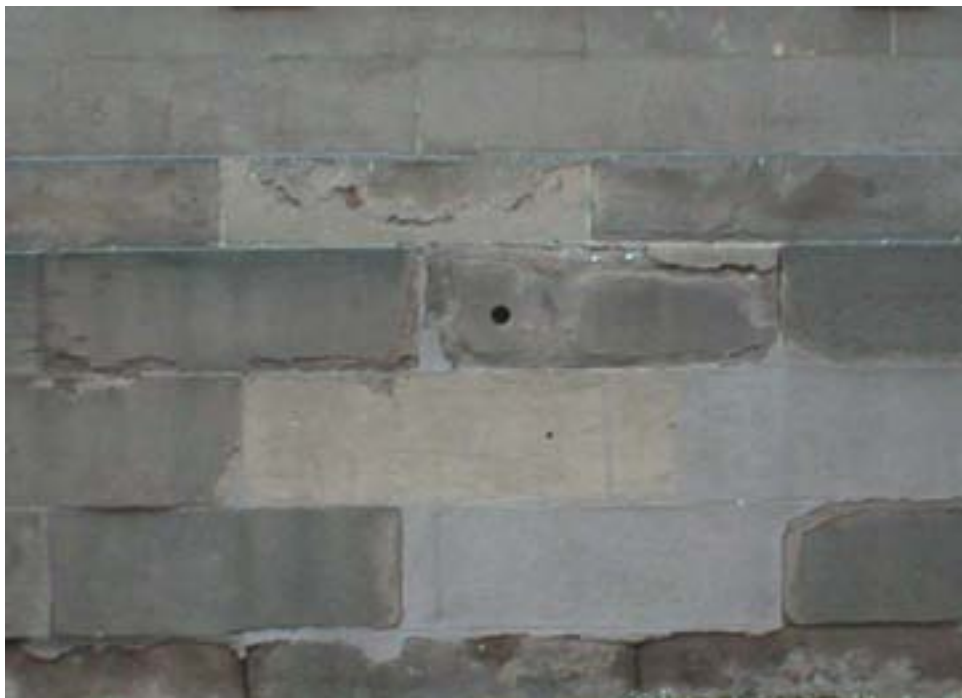
#4 Exterior masonry deterioration.

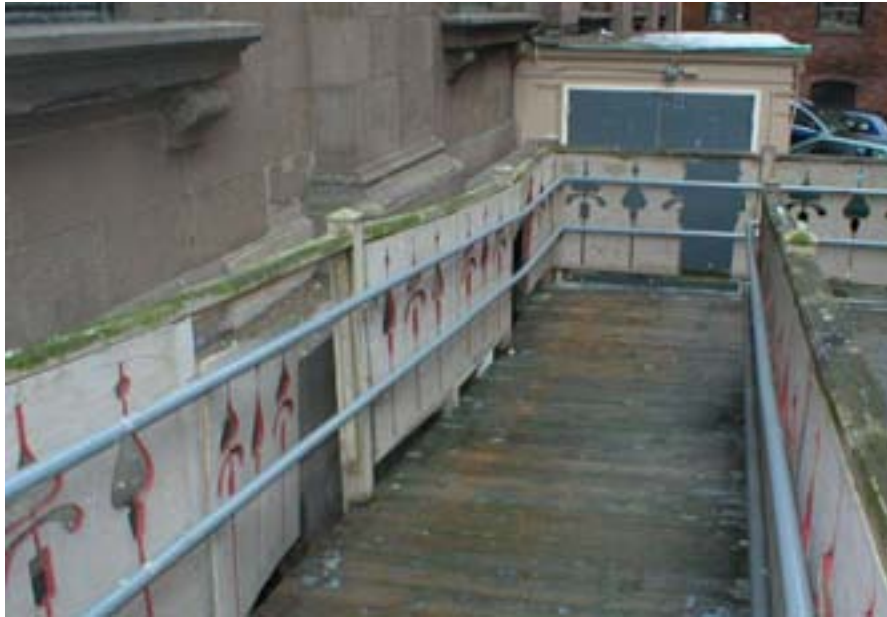
#5 Right side ramp and railing deteriorated and needing rebuilding.

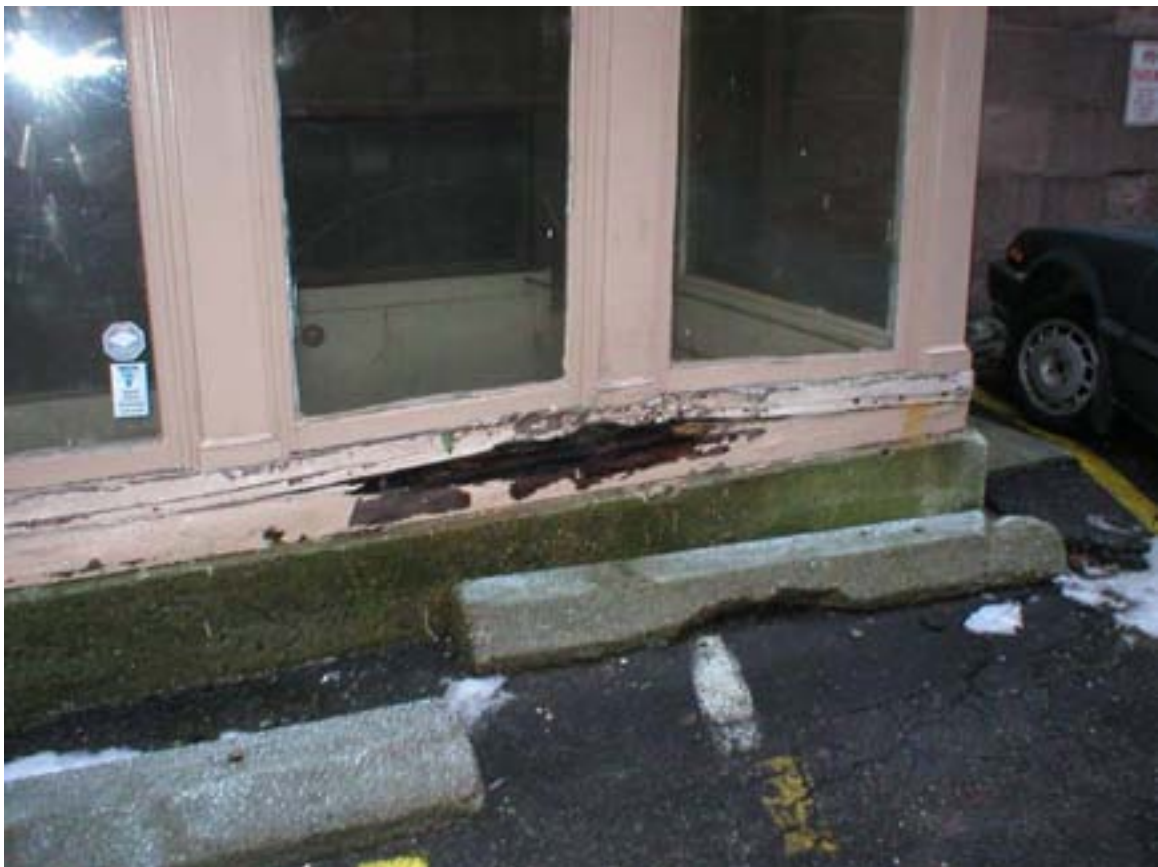
#6 Right side entry to basement level damaged and decayed. Needs rebuilding.

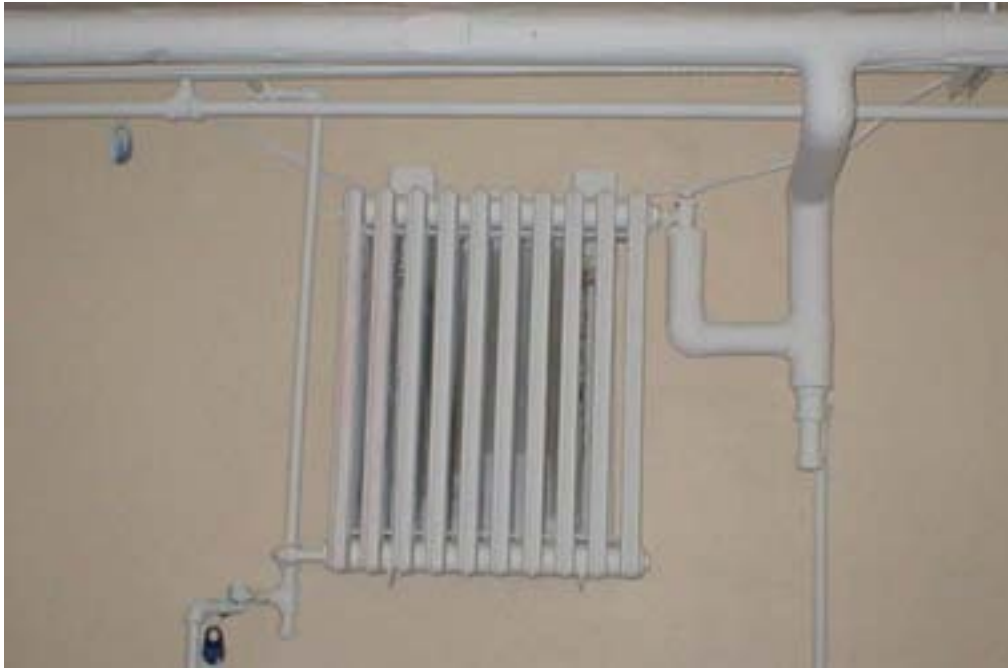
Heat is generated for the entire facility by *steam*. The steam is provided by Trigen-Boston Energy Corporation with no direct on-site generation. Heating *distribution* is by steam radiators and gravity warm air. There is possible asbestos containing insulation on the steam pipes in areas throughout the building.

#7 Steam radiator for heat distribution in basement.

It is recommended that the facility investigate the feasibility and associated costs for upgrading the heating system to a high efficiency, on site, gas fired, multi zone hydronic system. The system should be zoned with consideration to the varying demands of the different sections of the facility. This investment will provide greater flexibility of control resulting in increased comfort and long-term savings from both financial and environmental impact perspectives.

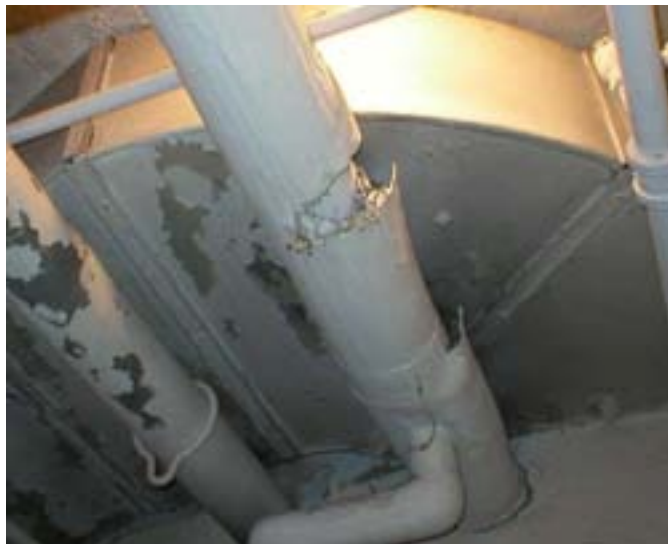
#8 Possible asbestos containing material with damage. Evaluate and abate as needed.

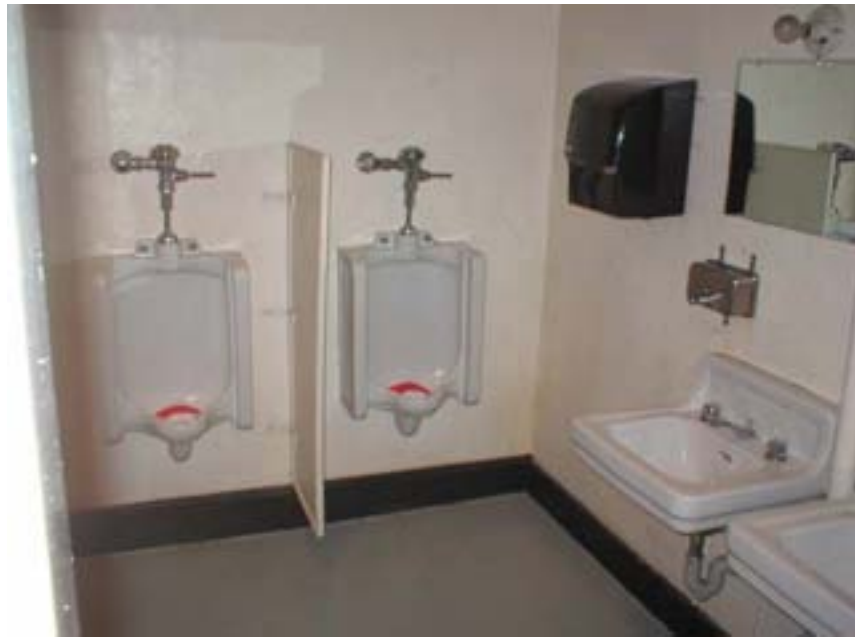
The primary *water* using equipment in the facility includes sinks in the restrooms and the kitchen. The equipment is mostly old and not efficient. The toilets and urinals in the restrooms are the primary generator of *sewer* use. The toilets and urinals are mostly old and are not efficient.

#9 Old bath fixtures. Upgrade to water conserving fixtures.

It is recommended that the inefficient toilets and urinals be replaced with fixtures meeting contemporary water consumption guidelines to reduce water and sewer usage. Toilets should use no more than 1.6 gallons per flush and urinals no more than 1 gallon per flush. Installing water

saving on/off aerators or automatic flow controls at the bathroom sinks will also help conserve water. Self-metering faucets using 0.25 gallons per cycle are the preferred option.
